# HOME INSPECTION REPORT

**123 Anywhere Street,  
Gulf Breeze FL, 32563**

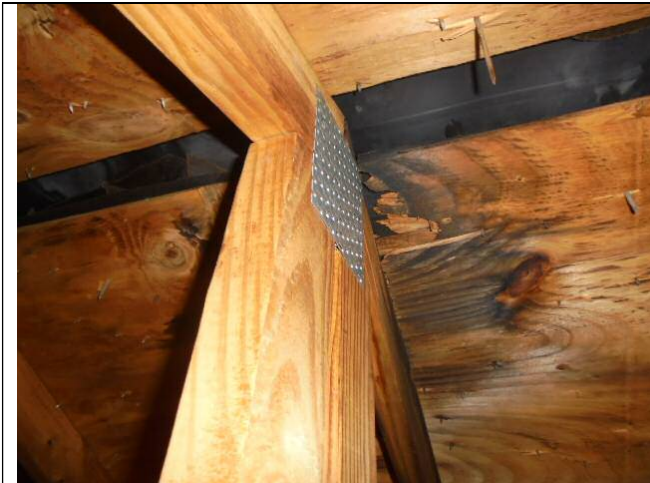
Localized rot was observed at the ridge vent in the attic

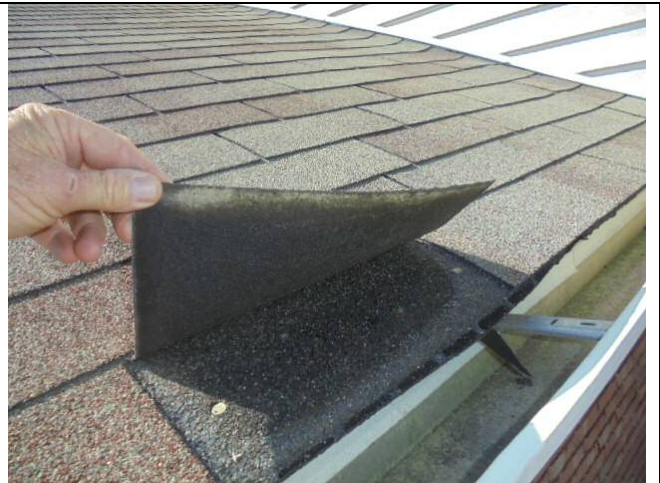
The leading edges of the starter row of shingles are not sealed at the eaves.

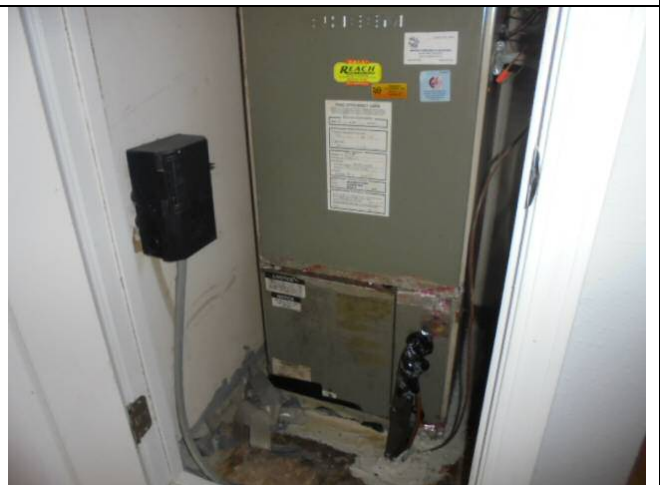
Many of the screws for the evaporator are missing and the interior components are in a state of disassembly/missing parts

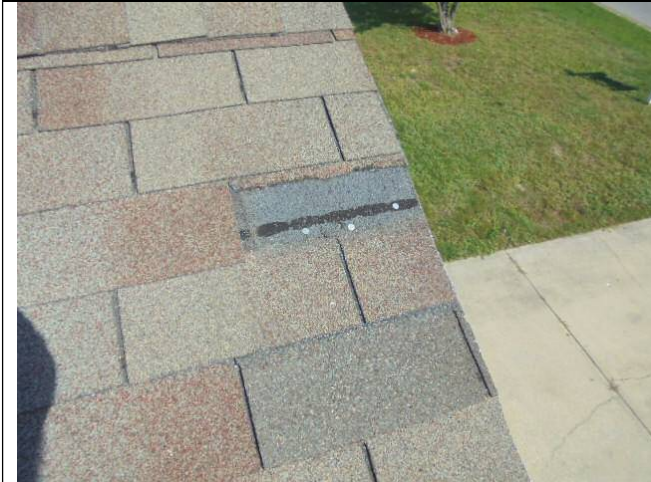
Missing shingles should be replaced as necessary.

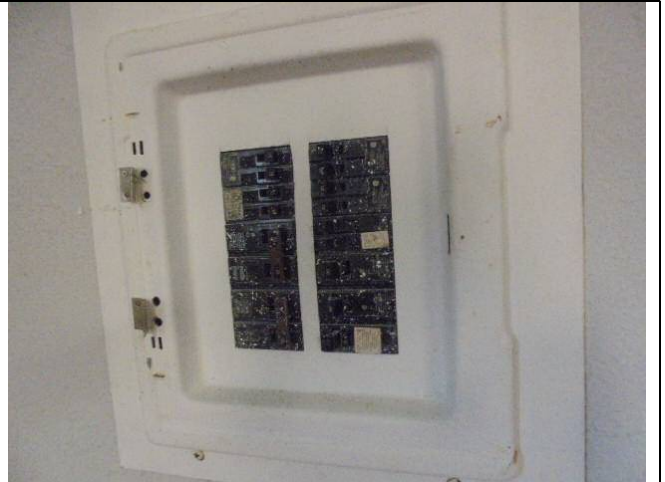
The cover for the distribution panel is damaged

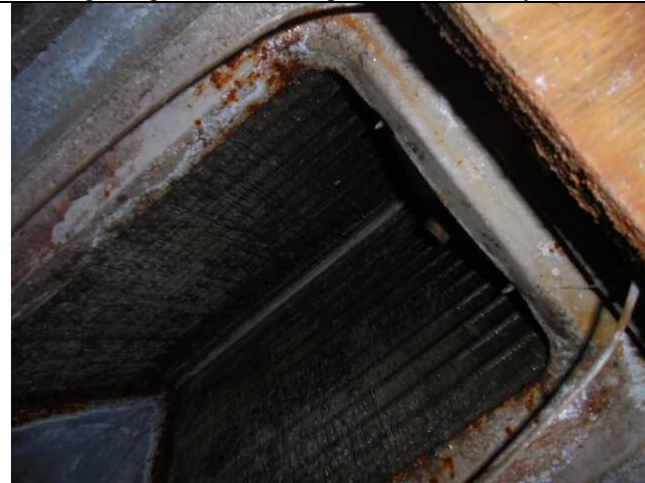
The interior coils were observed to be dirty and/or corroded. The cooling coils should be cleaned and/or leak checked as needed.

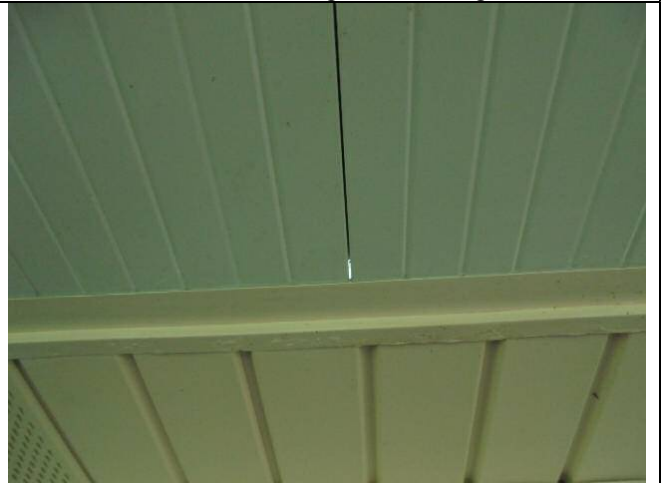
A proper flashing should be provided at the intersection of the exterior wall of the house and the deck/porch cover.

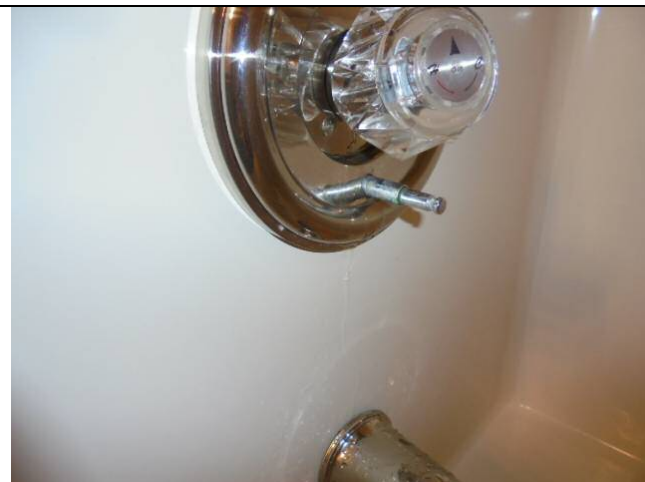
The bathroom tub and shower faucet(s) are leaking at the handle when the water is on.

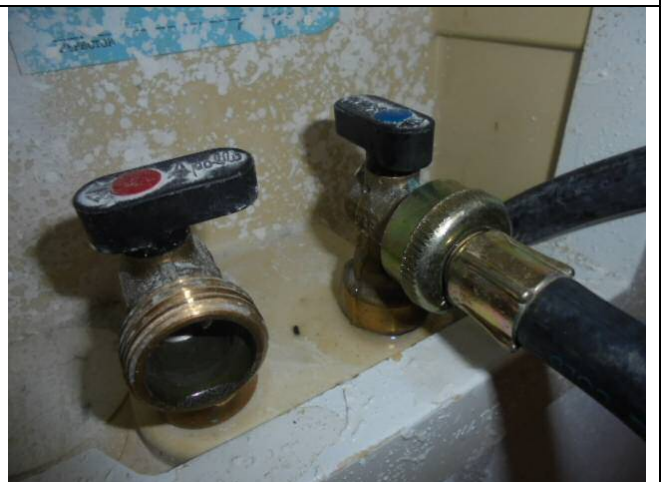
The laundry faucet leaks at the handle when the water is on

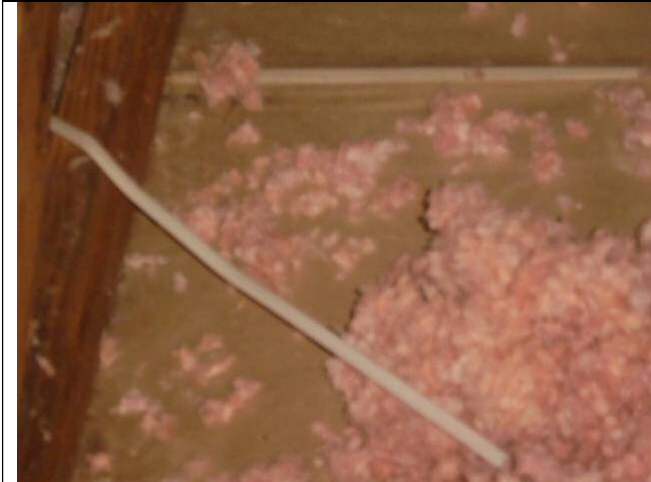
Insulation should be evened out. There are areas above the middle bedroom and hall that have no insulation.

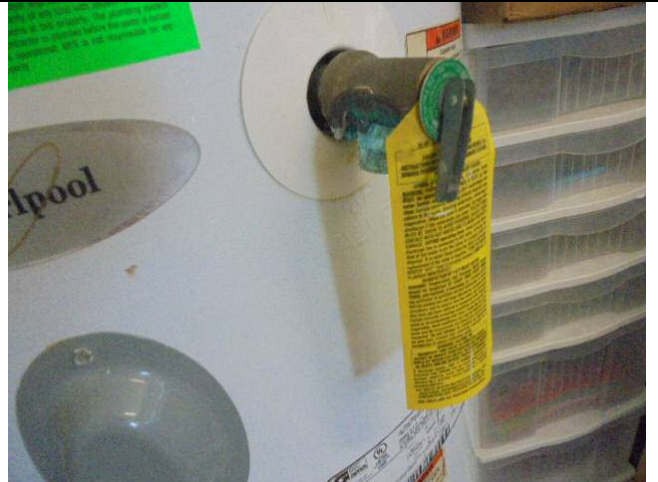
Discharge piping should be added to serve the Temperature and Pressure Relief (TPR) Valve for the water heater. It should terminate not less than 6 inches or more than 24 inches above the floor.
